Time to Clean Again?

Changes in Cleaning Frequency and Effectiveness at the
Richard A. Reynolds Groundwater Desalination Facility

Gabriela Handley
SPI

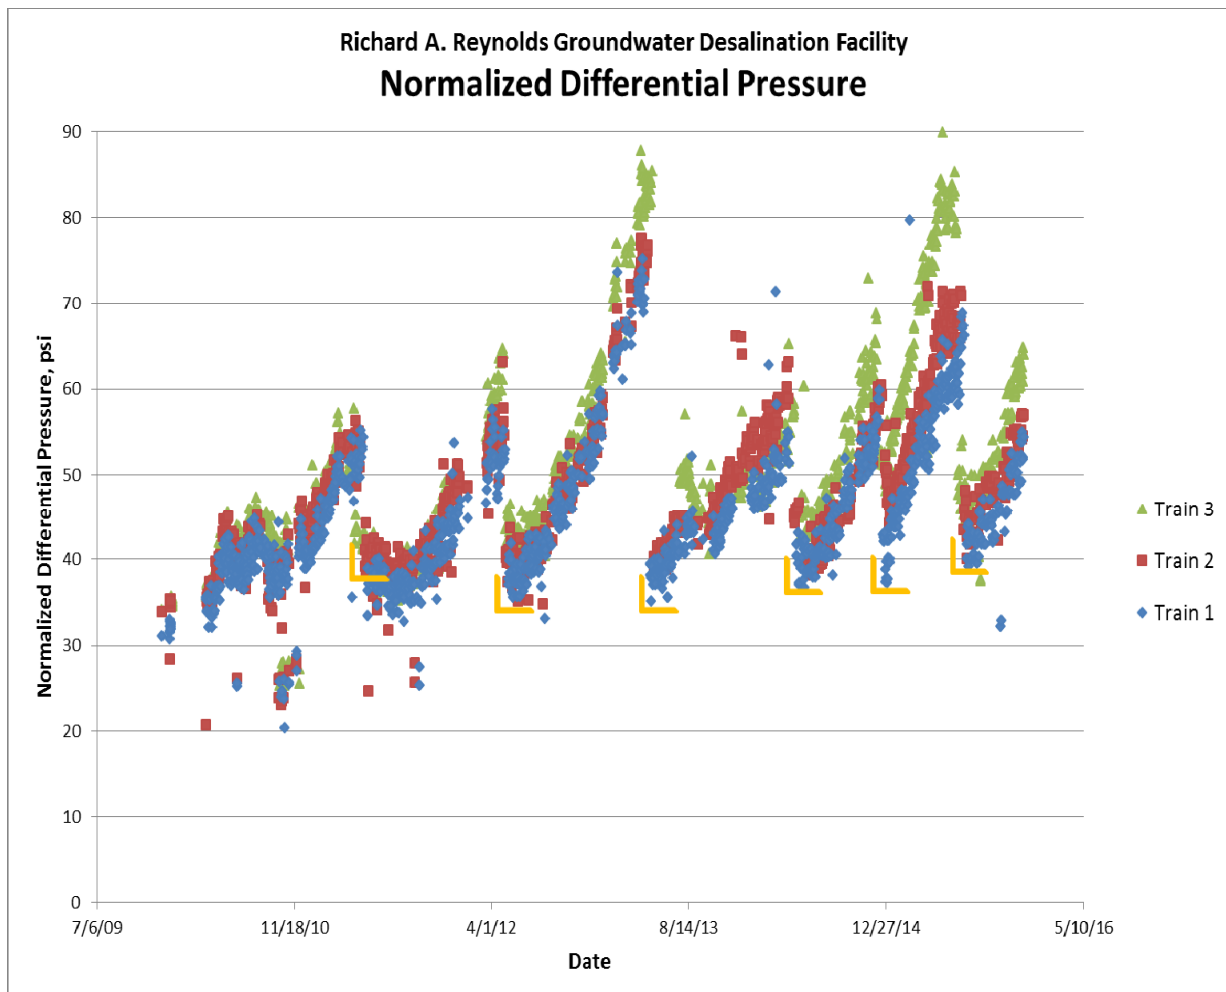
Membrane cleaning has been initiated based on significant increases in normalized differential pressure values.

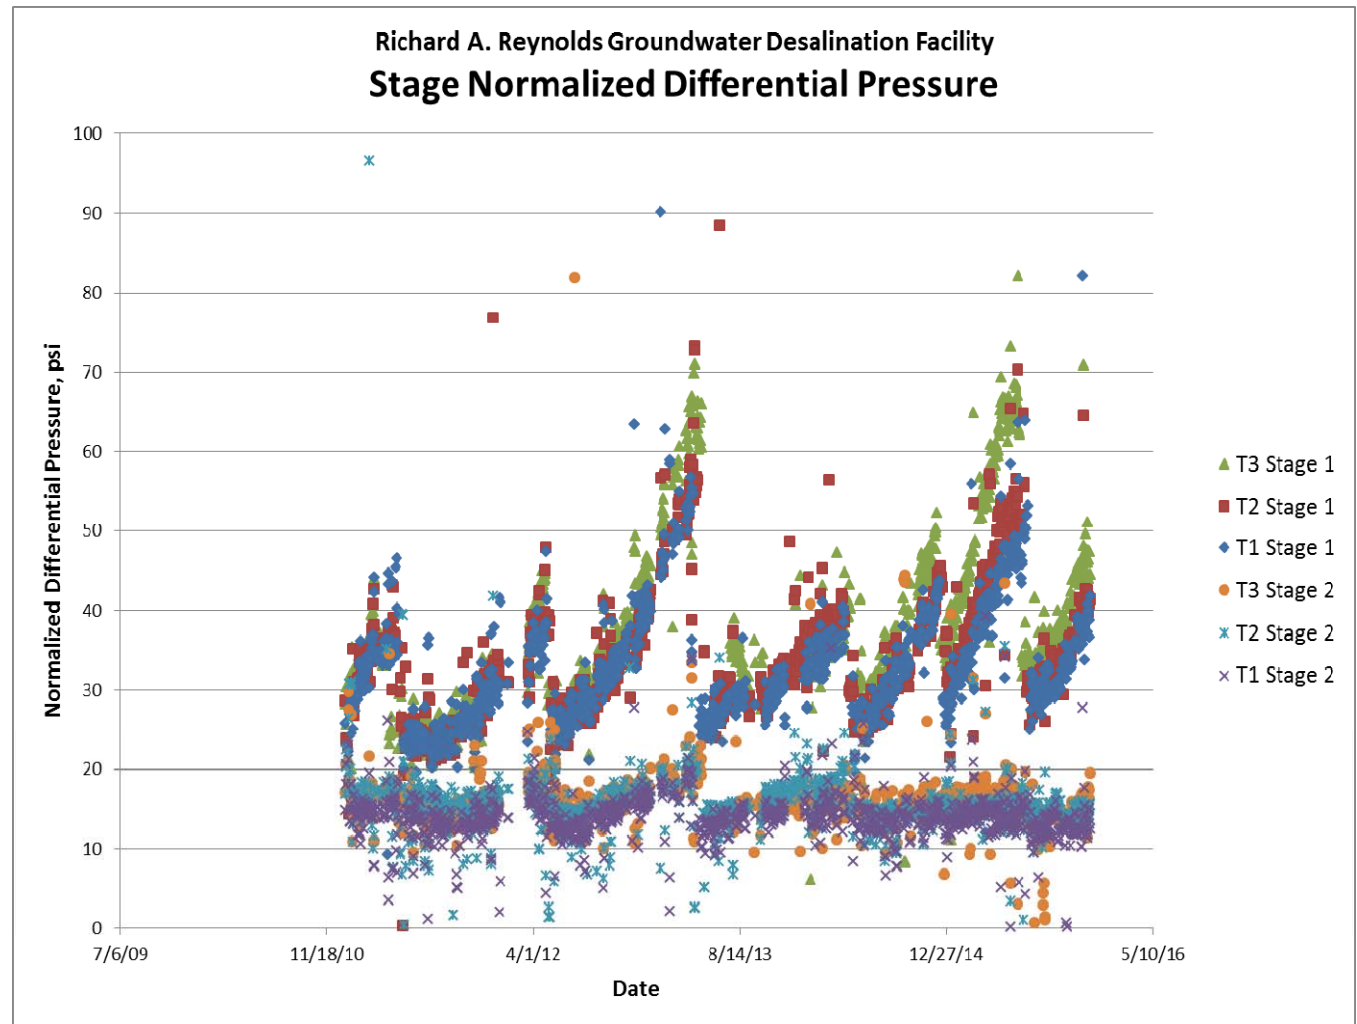
Increases in differential pressure are localized in the first stage.

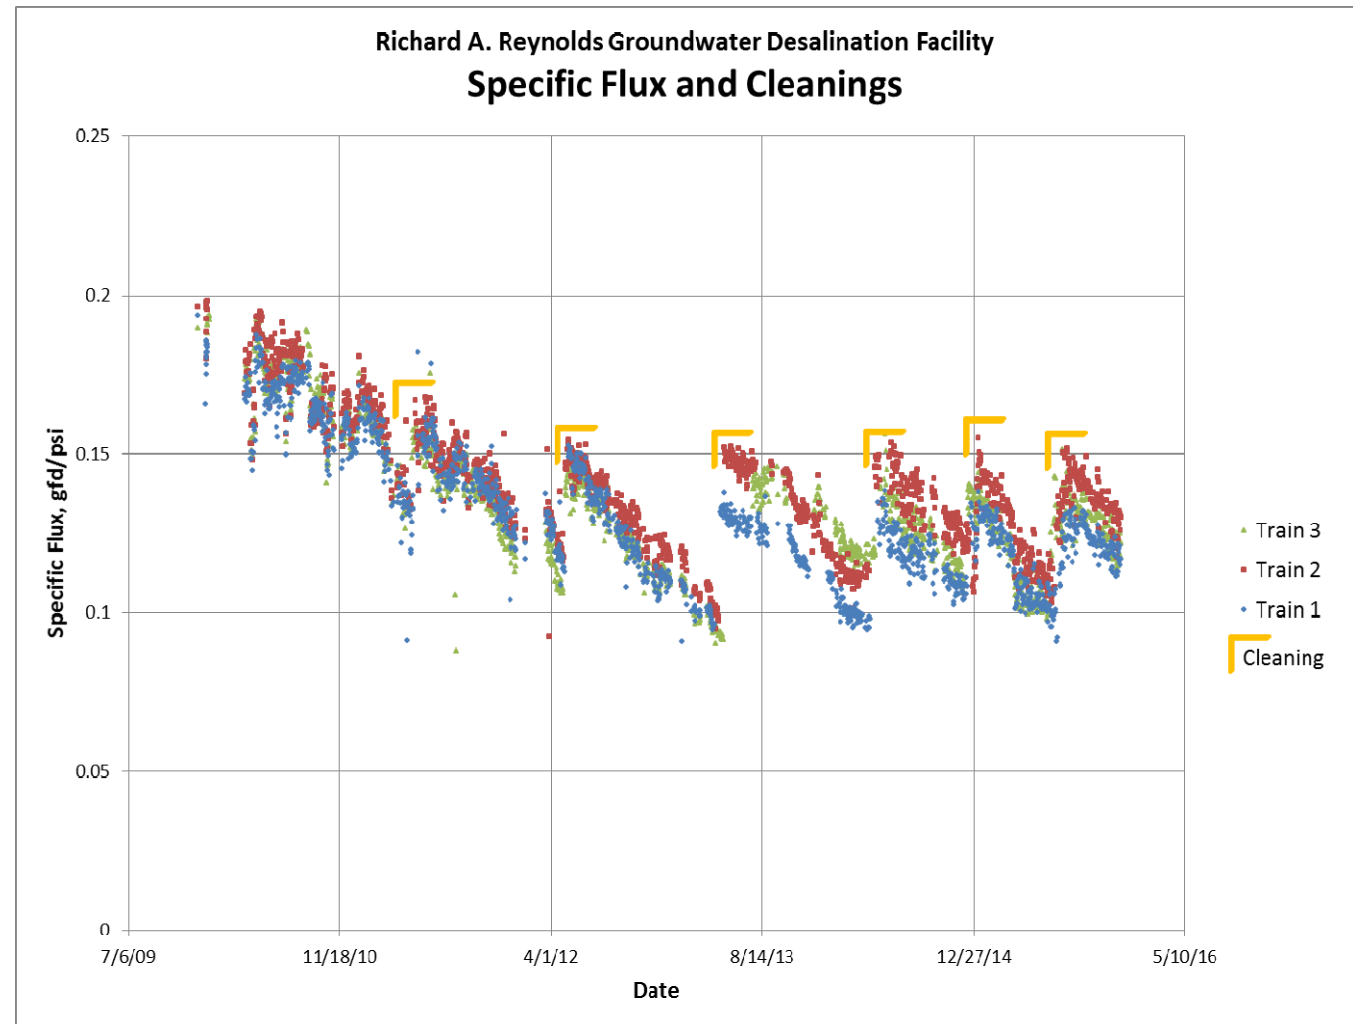
There has been a consistent decline in specific flux.

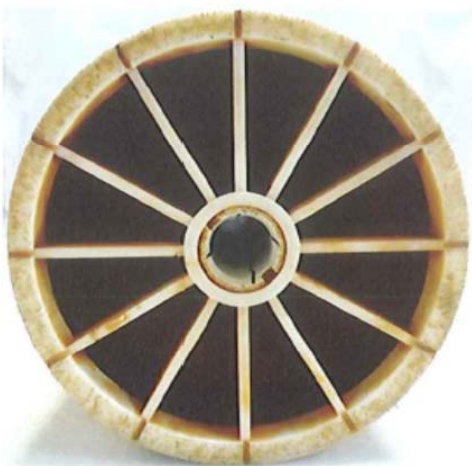
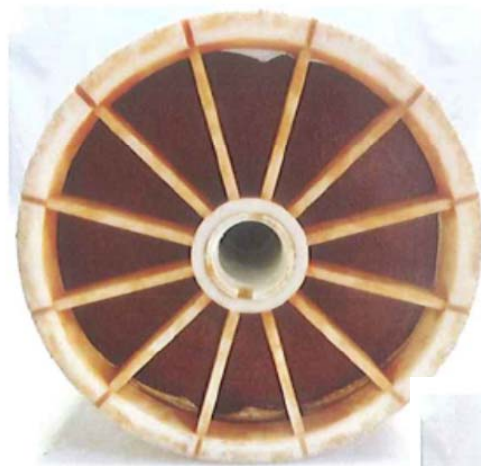
Membrane autopsies revealed heavy iron fouling and physical damage.

Feed ATD (left) and concentrate ATD (right)

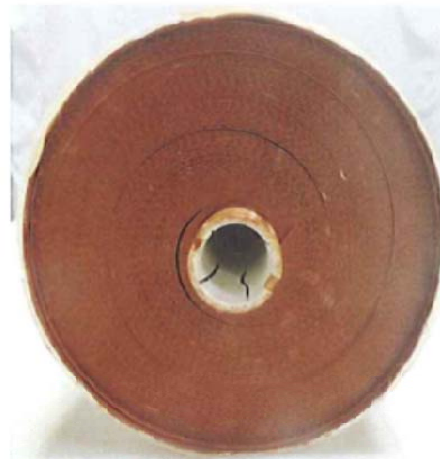
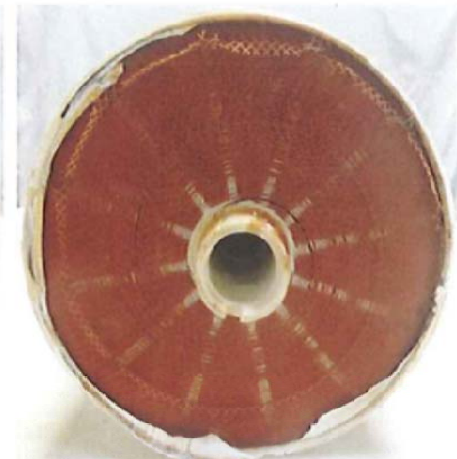
Feed scroll end (left) and concentrate scroll end (right) of SN#091012439

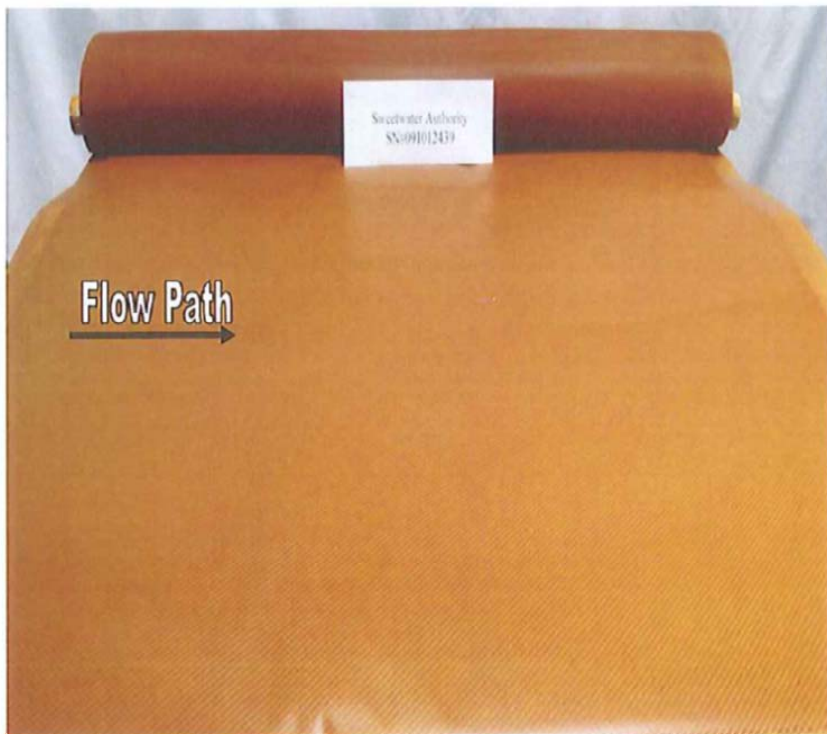
The membrane surface
of a lead element in the first stage.

Exposed membrane surface for SN#091012439

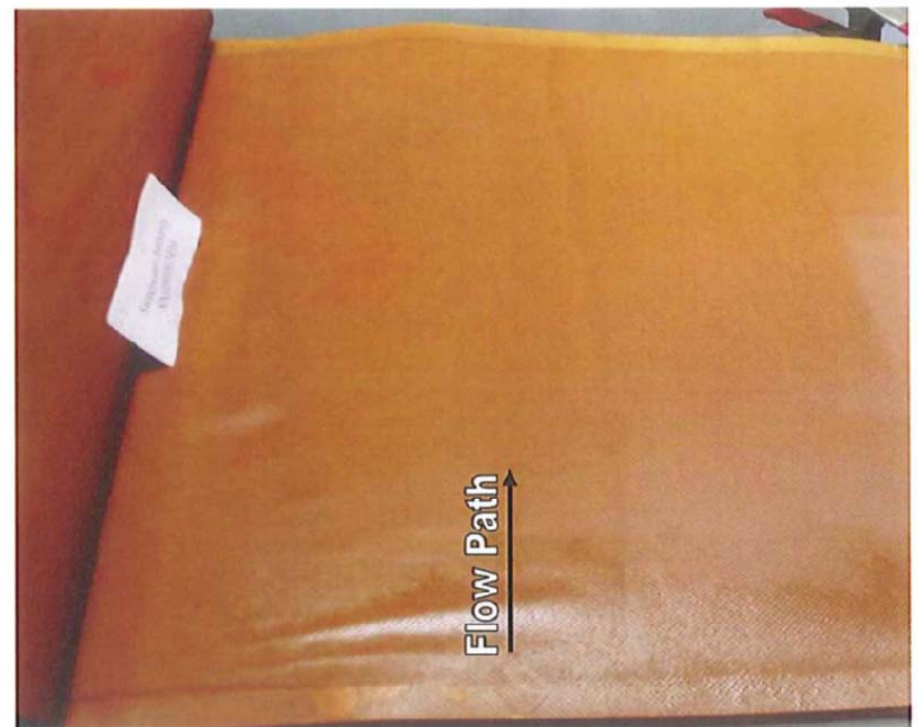
Image of membrane surface from feed end for SN# 091012439

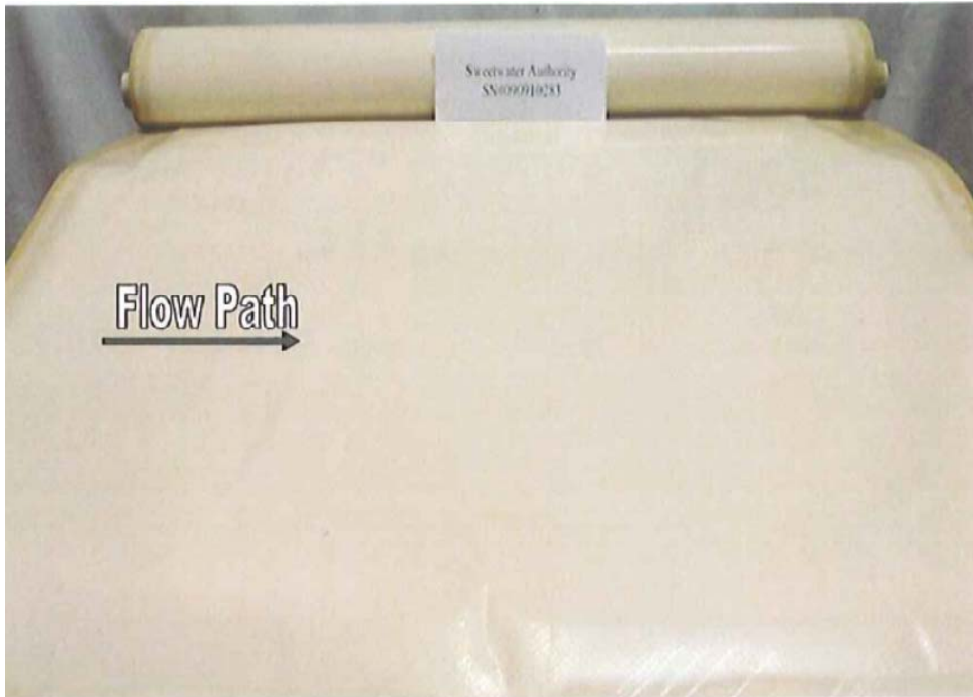
The membrane surface
of an element in the second stage

Exposed membrane surface for SN#090910283

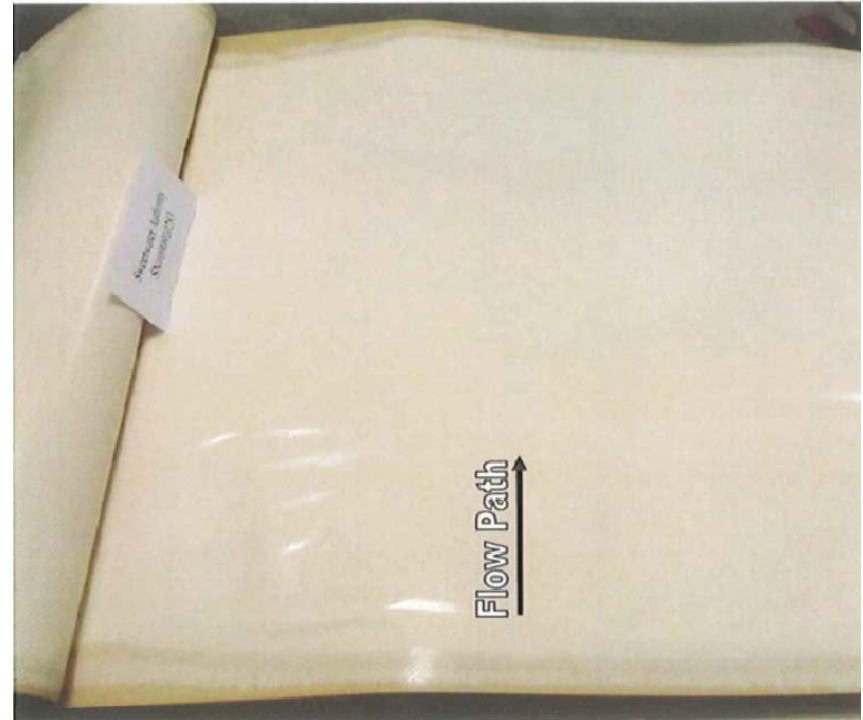
Image of membrane surface from feed end
