TIME TO CLEAN AGAIN? CHANGES IN CLEANING FREQUENCY AND EFFECTIVENESS AT THE RICHARD A. REYOLDS GROUNDWATER DESALINATION FACILITY

Gabriela J. Handley, Separation Processes, Inc. 3156 Lionshead Ave. Ste. 2 Carlsbad, CA 92010
Email: ghandley@spi-engineering.com   Phone: 760-400-3660

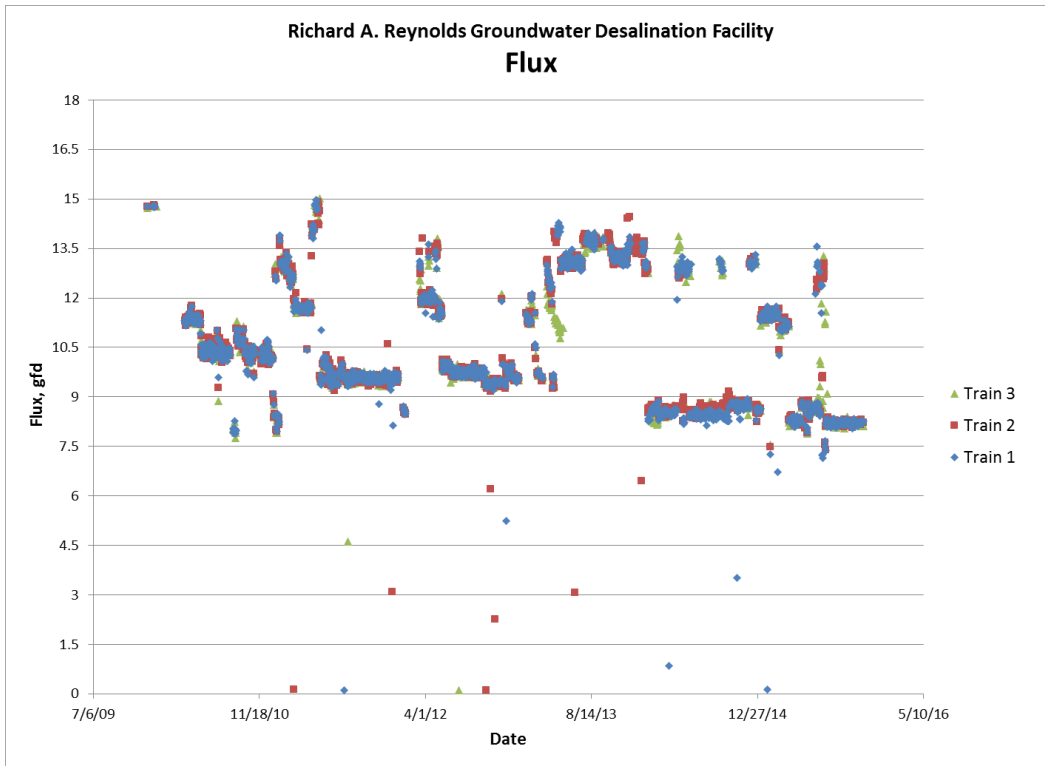
Figure 1: R.A.R. Historical Flux

RO Train Operating Conditions
Historically, during the dry season the Reynolds Desalination Facility would maintain a flux of approximately 9.5 gfd. During the wet season when additional wells were brought online, the flux became more variable between 12-14 gfd based on availability. Due to reduced production from the wells and permit limitations, since February 2014 the average flux during dry season has decreased to approximately 8.5 gfd. During the wet season of 2015, the average flux was approximately 11.3 gfd which is significantly lower than historical wet season fluxes. Not only were flux values lower during the most recent wet season but also the trains were only operated at this flux for a period of 3 months, (January-March 2015) due to limited production from those wells. **Figure *1*** below shows historical flux data for these membranes.

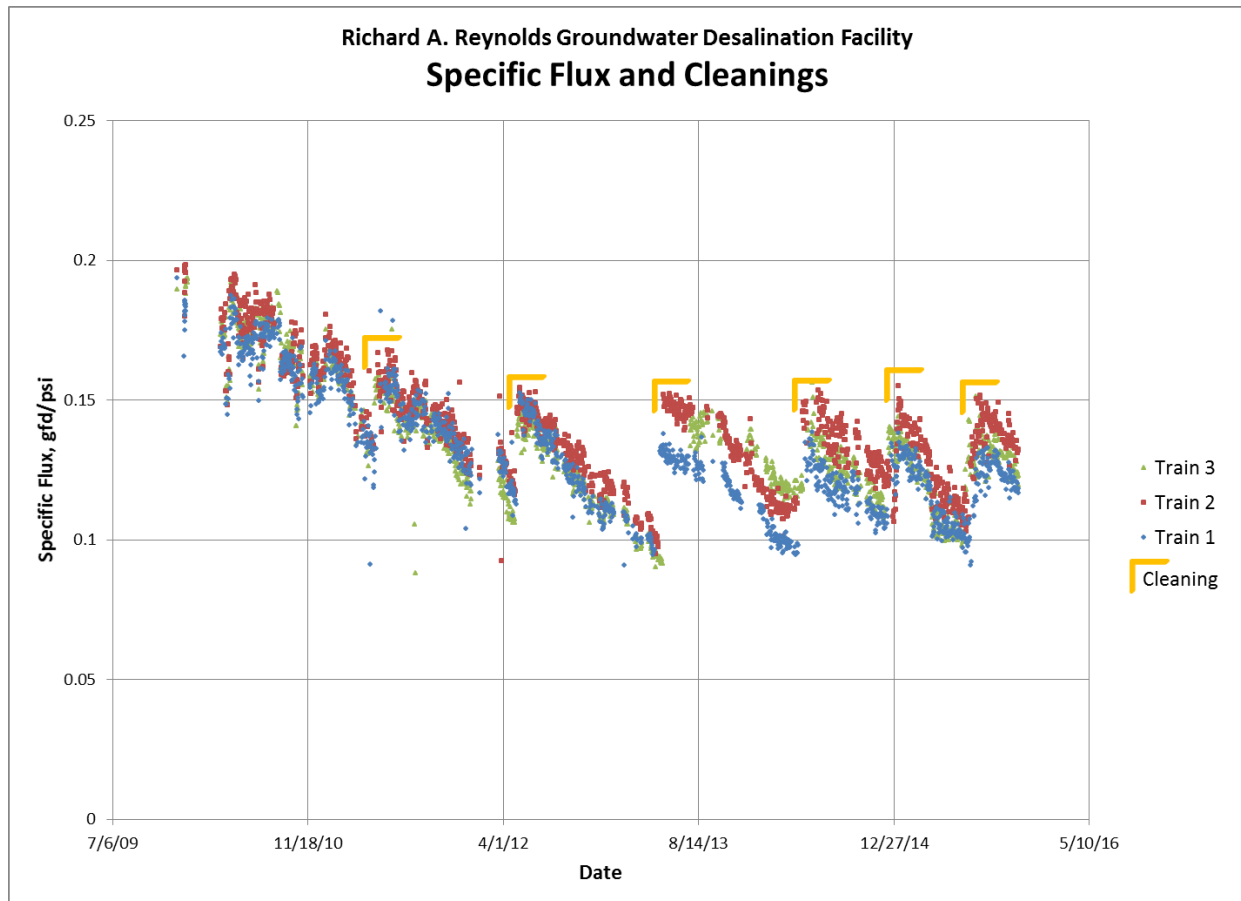
Figure 2: R.A.R. Specific Flux Trends

Specific Flux
The specific flux trends for the Reynolds Desalination Facility indicate a steady fouling rate since startup in 2010. During the wet season, the rate of fouling increases due to the increased flux, and perhaps changes in feedwater chemistry from the contribution of wells 3 and 4. The cleanings performed in May 2011 with Avista P303 cleaner showed consistent results for all three trains. The cleanings resulted in a step up in specific flux, but startup values were not achieved. The first set of cleaning increased specific flux values back up to 85-90% of startup for all three trains. The second set of cleanings in May 2012 also exhibited consistent results between the three trains, but the 2012 cleanings were only able to recover membrane permeability to 75-80% of startup performance.

In May 2013, train 1 was cleaned with Avista P303 again and lost a considerable amount of flux only being able to achieve 70-75% of the startup value. Consequently, trains 2 and 3 were

cleaned with Avista P130 which yielded better results with specific flux values returning to 78% of startup values. In May 2014 all three trains were cleaned with Avista P130 with trains 2 and 3 able to achieve similar results to the last cleaning with specific flux values returning to 79% of the original startup values. Train 1 was able to achieve post-clean specific flux values of 70% of original startup values which is consistent with the results seen with the last cleaning performed with Avista P130.

The cleaning performed on the trains in December 2014 yielded similar results to the May 2014 cleaning. Trains 2 and 3 post-clean values were slightly lower than the previous cleaning at 78% of startup values and Train 1 post-clean values were once again around 70% of startup values. In the two weeks following this cleaning, specific flux values for Train 2 began low and gradually increased. After taking a closer look at the data it appeared that this may have been a result of incorrect pressure readings during this period. During this time, pressures decreased by 10-15 psi while flow and feed conductivity remained relatively consistent.

In the months following this cleaning, specific flux values continued to decline at a faster rate. In July 2015 specific flux values had already reached historically low values once again after only 7 months of operation in between cleanings. **Figure 2** below illustrates the specific flux trends over the lifetime of these membranes so far.

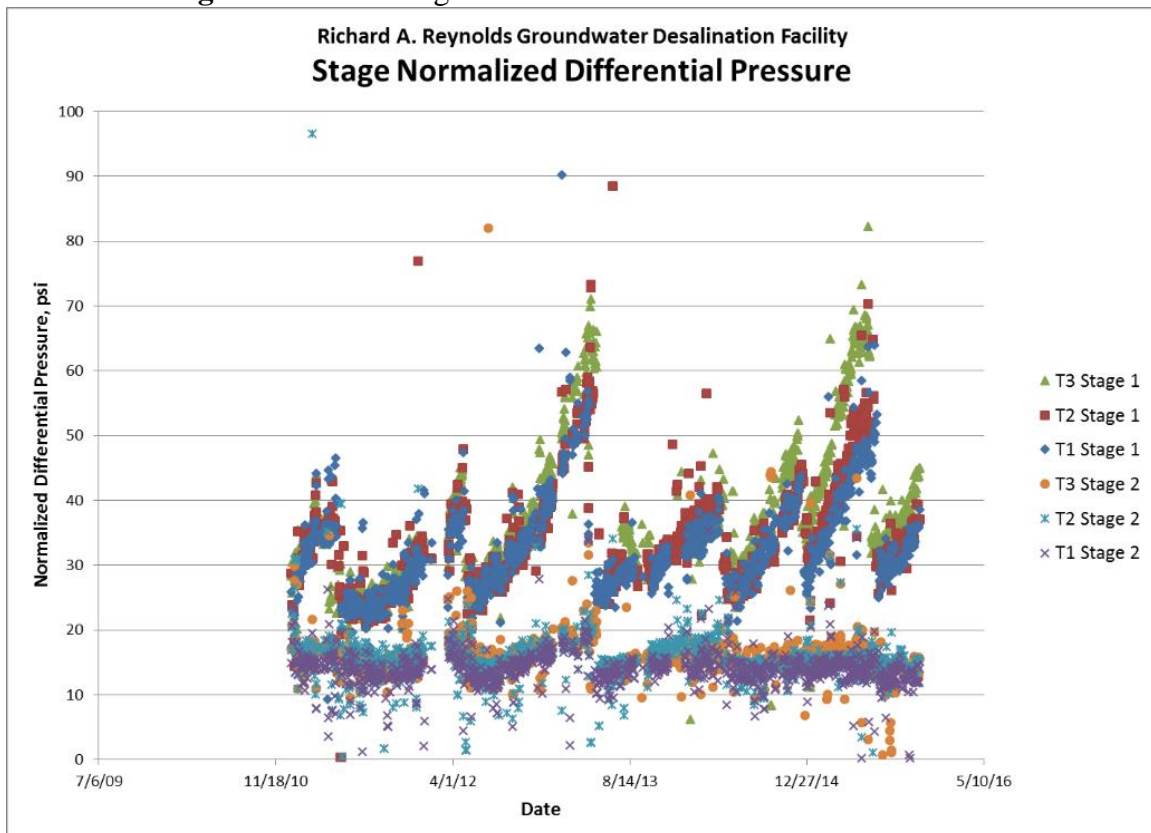
Figure 3: RA.R. Stage Normalized Differential Pressure Trends

When the trains were cleaned again in July 2015, post clean overall normalized differential pressure values came back down closer to 40 psi. This cleaning appeared to be more effective in terms of reducing differential pressure however once again it not entirely successful in completely removing the foulant from the membrane surface. As mentioned previously, fouling remains localized to the first stage which is evident in

Figure 3 below which shows individual stage normalized differential pressure values. **Figure 4** illustrates the overall train normalized differential pressure trends.

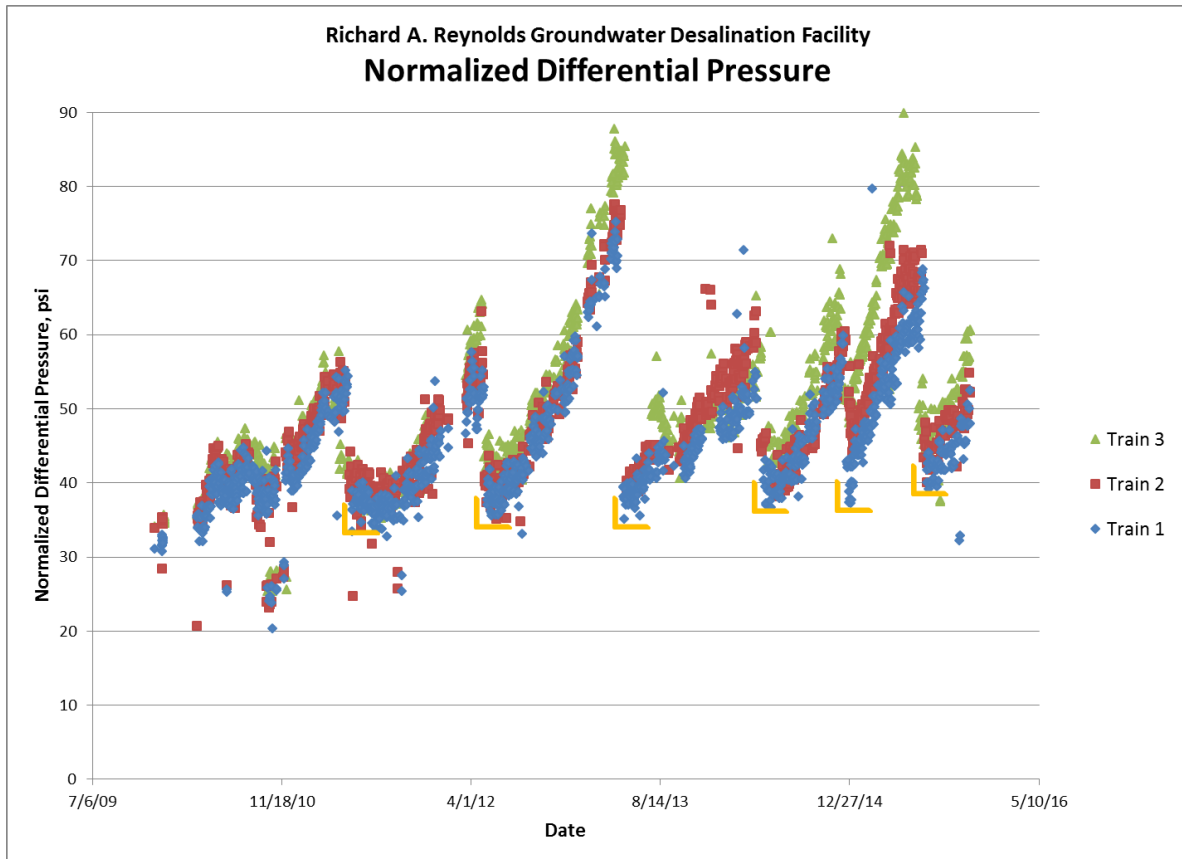
Figure 4:R.A.R. Normalized Differential Pressure Trends

The cleaning effectiveness with the P303 cleanings prior to 2013 was apparent in the differential pressure data (Figure 9). After all cleanings with P303, including the 2013 cleaning of Train 1, the train normalized differential pressure values were returned to approximately 40 psi. The increase in differential pressure was localized in the first stage of the trains, as shown in Figure 10.

The May 2013 cleaning of Train 2 with Avista 130 product also returned the train to approximately 40 psi. The July 2013 Train 3 cleaning resulted in a significant drop in normalized differential pressure (85 psi to 40-50 psi). The fourth cleaning performed May 2014 was able to bring normalized dP values back to the baseline of 40 psi for all trains. The December 2014 cleaning was not as effective at restoring dP values to the baseline of 40 psi. Furthermore, in just 3 weeks dP values are already creeping up towards 50 psi with Train 3 being closer to 60 psi.

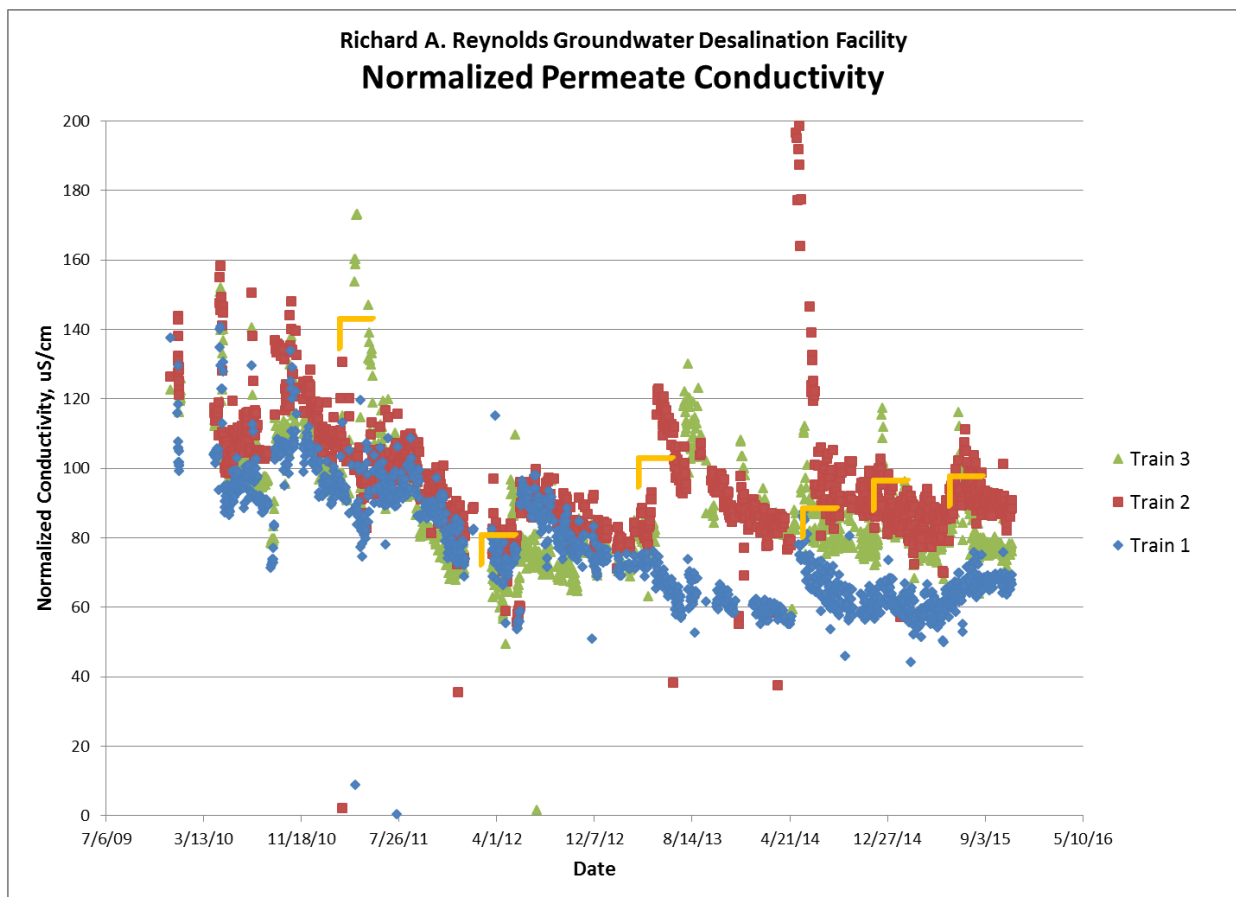
Figure 5: R.A.R. Normalized Permeate Conductivity Trends

Despite annual cleanings, which can often lead to increases in permeate conductivity, the Reynolds Desalination Facility permeate conductivity has improved since startup. The fact that the normalized permeate conductivity has not returned to startup conditions following previous cleanings (2011, 2012) supports the observation that the cleanings have not been completely effective in removing the foulant from the membrane surface. This observation is also true for the 2013 cleaning of Train 1 using P303, which has offered the least effective cleaning to date and also failed to impact the normalized permeate conductivity as well.

The May 2012 Avista 130 cleanings on Trains 2 and 3 caused a jump in permeate conductivity from 85 μS/cm to 120 μS/cm, which is approximately the same as the startup conductivity of the Toray membrane. This increase, in combination with the improved specific flux value, strongly suggests that the fouling layer was more successfully removed. The increase could also be a consequence of the cleanings unmasking physical damage on the membrane (seen in previous autopsies), however the increase in conductivity did not increase beyond startup values. When the trains were cleaned again in May 2014, Train 2 saw a large increase in permeate conductivity from around 80 μS/cm to 220 μS/cm which is higher than startup conductivity values. It is believed that this was the result of delamination of some second stage membranes. These membranes were replaced with new elements and overall permeate conductivity returned to values consistent with what they were previous to the cleaning. Train 1 conductivities increased from 55 μS/cm to 80 μS/cm following the May 2014 cleaning then settled around 60

µS/cm until the next cleaning. Train 3 experienced an increase from 80 µS/cm to 110 µS/cm immediately following the cleaning and within about 2-3 weeks values had settled back down around 75 µS/cm.

The December 2014 cleaning caused a similar increase in conductivity as the previous cleaning for train 3 however trains 1 and 2 saw virtually no change in permeate conductivity and stabilized at about 60 µS/cm and 90 µS/cm respectively. In the months following the cleaning normalized permeate conductivity values continued to improve slightly as Trains 2 and 3 stabilized at approximately 85 µS/cm and Train 1 values at 55-60 µS/cm. In terms of normalized permeate conductivity, the most recent cleaning performed in 2015 appear to have been slightly more effective with a larger increase in values observed immediately following the cleaning. Shortly after, normalized permeate conductivity values decreased and stabilized at approximately 65 µS/cm for Train 1, 85 µS/cm for Train 2 and 75 µS/cm for Train 3 which was the largest improvement of the three trains. Historical normalized permeate conductivity trends are shown below in **Figure 5**.

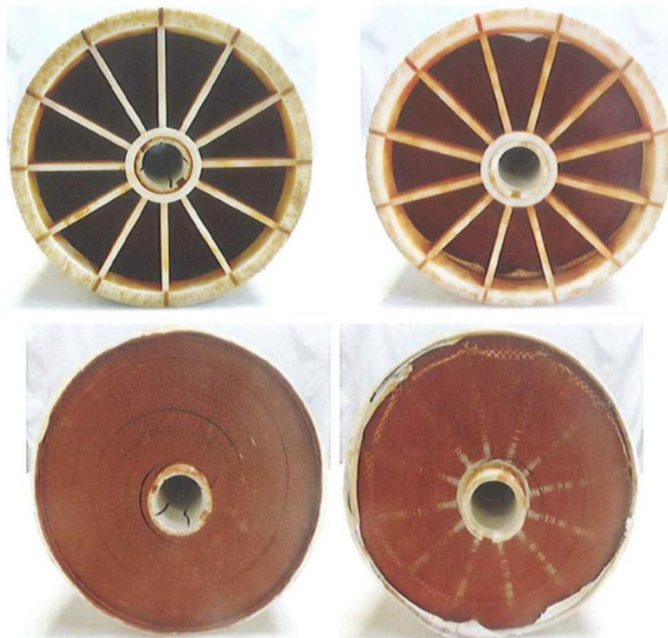
Figure 6: First Stage Element Fouling Evidence

In early 2013 when normalized differential pressure values began to rise at an increased rate together Sweetwater, SPI, and Avista began to investigate the cause and find possible solutions. In April 2013, an element autopsy was performed by Avista Technologies on one first stage and one second stage element from Train 1. The first stage element was heavily fouled and physically damaged. Telescoping, membrane tears, and delamination of the membrane leaves and glue lines were observed. The foulant was found to be 43% inorganic and 57% organic material based on a loss on ignition test. The inorganic foulant was comprised of iron, silicon, calcium, and aluminum. This is consistent with silts and clays with some iron and calcium oxides. Some colloidal silica was also observed. **Figure 6** below shows the extent of fouling and mechanical damage to the first stage elements observed.
